The Romanesque-style rural Churchs of Portugal: An initial stride towards the complete digitalization by Heritage-BIM. The case study of S. João de Calvos (Guimarães, 13th Cent. AD).

Fabio Sitzia (PI)<sup>1</sup>, Jorge Ribeiro (co-PI)<sup>2</sup>, Vera Pires<sup>1</sup>, José Mirao<sup>1</sup>, Bruno Figueiredo<sup>2,</sup> Paulo Bernardes<sup>2</sup>, Joao Sequeira<sup>3</sup>, Rebeca Rotea<sup>2</sup>, Carla Fernandes<sup>4</sup>, Filipe Brandao<sup>2</sup>

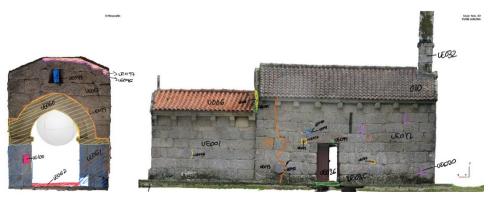
Figure 3: Working process of stratigraphic analysis: differentiation of SU

In order to identify the construction phases of the church, the team is carrying out a study based on the archaeology of architecture, the stratigraphic analysis of elevations, which first identifies and then arranges the traces that the constructive and destructive actions have left in the building, the Stratigraphic Units (SU). Once these have been identified, they are drawn on the elevations of the chapel (Fig. 3), arranged and the physical relationships (what joins, adjoins or cuts what?) and temporal relationships (what is prior, contemporary or subsequent to what?) are documented. In the final phase, they will be arranged in a construction sequence.

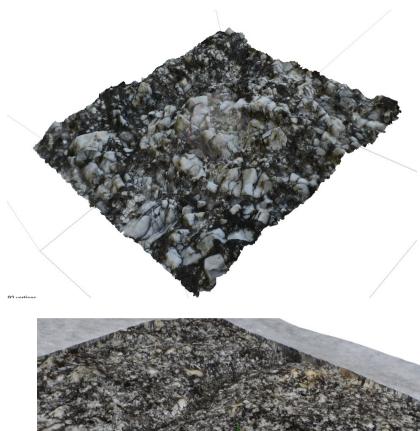
Figure 5: Examples of photogrammetric surveys

Photogrammetry was carried out at specific points of the monument subject to degradation conditions or areas where fractures are present. Normally, surfaces with a size of 100 cm<sup>2</sup> are reproduced (Fig. 5). Digital Elevation Models (DEM) are associated with each surface. The objective is to perform photogrammetric surveys at biennial intervals and detect micro-morphological variations and volumetric loss of samples, quantifying the progression of stone degradation.
